Manhole Inspection Summary

Manhole # S33OO_026MH

Location Address: **2226 MARYLAND AVE**

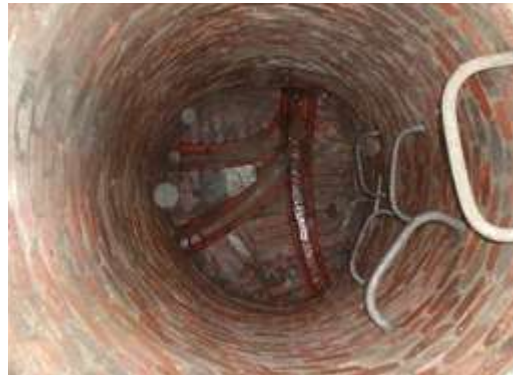
Top View

Barrel infiltration. Corroded steps.
Evidence of surcharge - Bench debris.

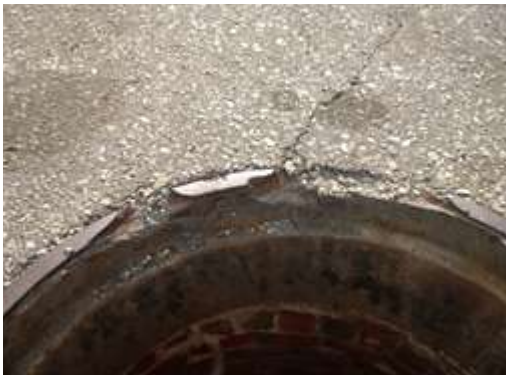
Defect

Broken frame.

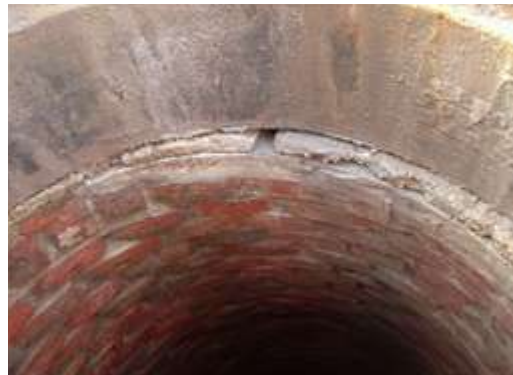
Defect

Frame leaks. Adjustment infiltration -
other side.

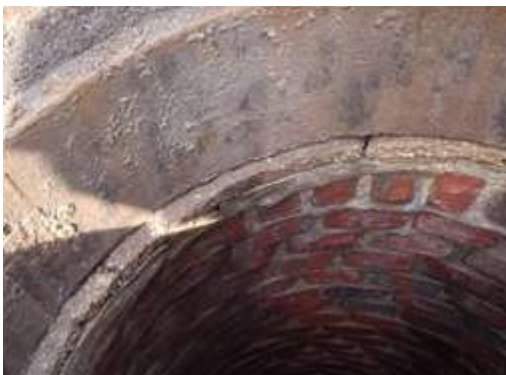
Defect

Frame leaks. Adjustment infiltration.

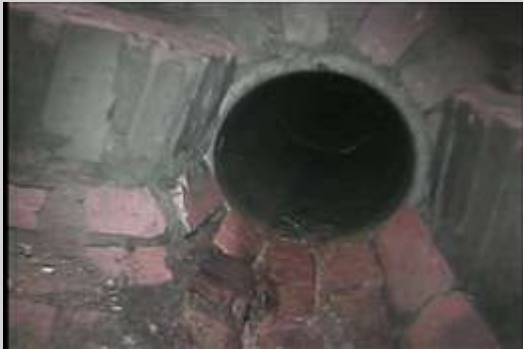
8 in. Circular Gravity Sewer Pipe Out @ 12 O'Clock

Invert Depth: **11.40** (ft.) Flow Characteristics: **Slow**

Infiltration: **None** Pipe Seal Cond: **Unknown**

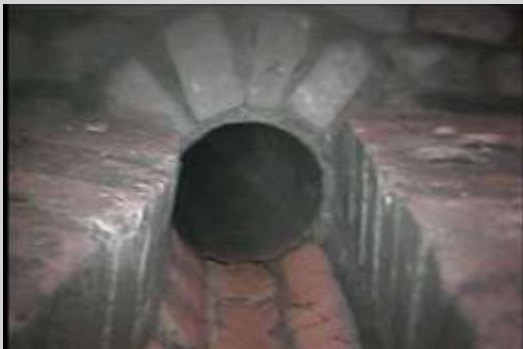
8 in. Circular Gravity Sewer Pipe In @ 6 O'Clock

Invert Depth: **11.20** (ft.) Flow Characteristics: **Slow**

Infiltration: **None** Pipe Seal Cond: **Unknown**

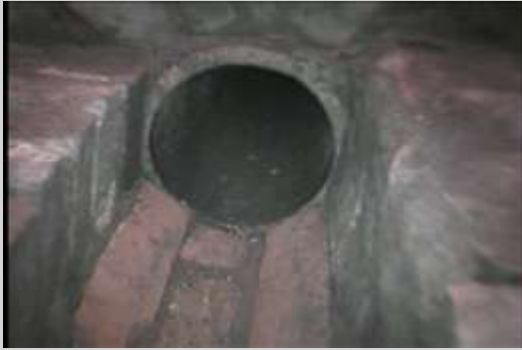
Pipe In @ 8 O'Clock

Invert Depth: **10.75** (ft.) Flow Characteristics: **Slow**

Infiltration: **None**

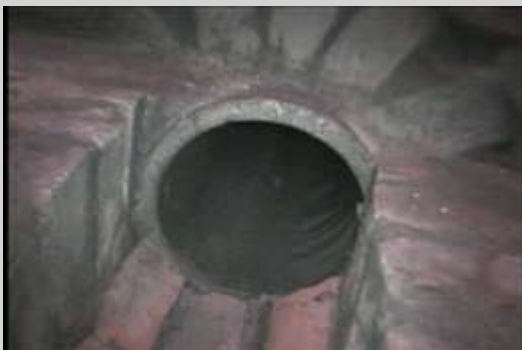
Pipe In @ 9 O'Clock

Invert Depth: **10.72** (ft.) Flow Characteristics: **Slow**

Infiltration: **None**
